Comparative study of active infrared thermography, laser vibrometry and laser ultrasonic techniques in application to the inspection of graphite/epoxy composite parts

Three nondestructive testing techniques, namely, active infrared thermography, laser vibrometry and laser ultrasound, have been comparatively applied in the inspection of a graphite epoxy sample characterized by a complicated geometry to demonstrate advantages and drawbacks of each technique in the detection of various types of defects.

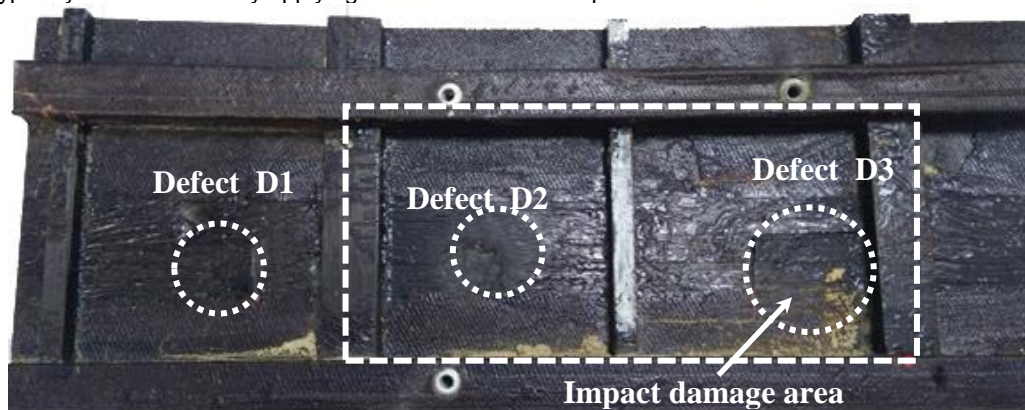
The 250×100×2.5 mm graphite epoxy test sample shown in figure 1 represented a fragment of a composite cylindrical case used in the aerospace industry. The main panel of a curved shape was strengthened with two types of ribs also made of graphite epoxy and contained three artificially-made defects (specified as 1, 2 and 3 in figure 1): two 12 mm-long thin vertical slits simulating cracks, local wall thinning with 15 mm-diameter material loss from 40 to 50% and 15 J impact damage. Since thinning-like (“corrosion-type”) defects are not typical in real composite parts, this kind of defect was used to show how local variations of main panel thickness and the presence of ribs affect surface temperature. Two other defects, in fact, simulated composite cracking that can occur in both lateral and in-depth directions. The through-the-sample cracks could not be detected visually, therefore, to some extent, they simulated vertical “kissing” cracks which are typically hard to detect by applying common NDT techniques.

Fig. 1: Test graphite epoxy sample (rear view, defect 1 - through-the-sample (“kissing”) cracks, defect 2 - 40-50% wall thinning, defect 3 - 15 J impact damage, square dashed area was tested by laser ultrasonics)

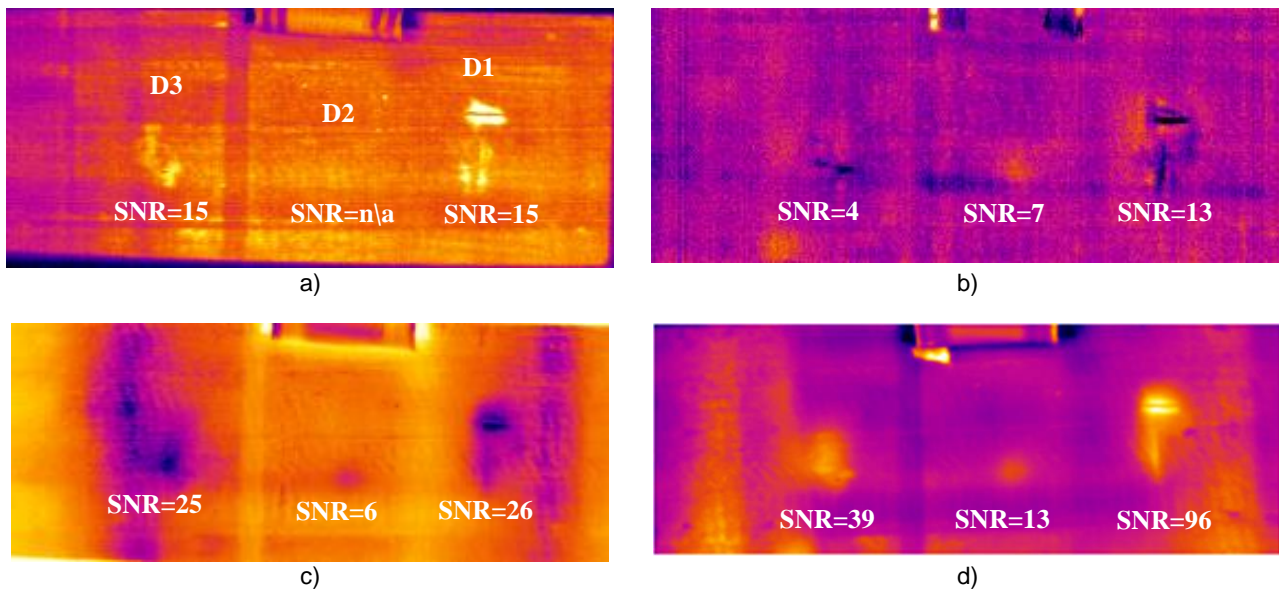
Flash heating was not powerful enough to ensure a detectable temperature elevation over the area with material loss while two other defects appear clearly in the source image (figure 2a). Applying PCA has allowed to stress the material loss (SNR=7) but worsened visibility of two other defects (figure 2b). This is a typical selective feature of the PCA method which concentrates particular types of temperature patterns in particular components. The thermogram in Fig. 2c illustrates why halogen lamps are often used in active thermal NDT devices due to high energy delivered for some seconds of heating (see the results of the pulsed test in figure 2d). However, the highest SNR values for all three defects appeared in the case of low-frequency thermal waves (figure 2d).

Fig. 2: Test results, optical heating: a-Xenon tube, source image, b-same as a), PCA image; c-halogen lamps, pulsed heating for 10 s; PCA image; d-halogen lamps, frequency 0.07 Hz, PCA image

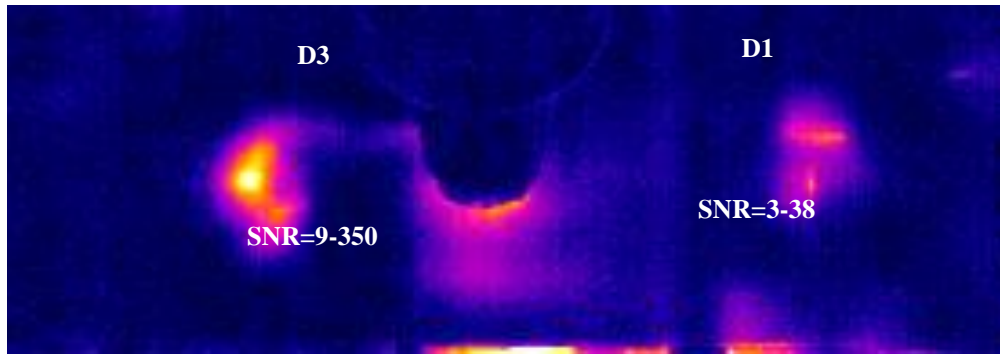
Fig. 3: Temperature distribution on sample surface under ultrasonic stimulation (22 kHz, 300 W electric power, magnetostrictive device in the centre)

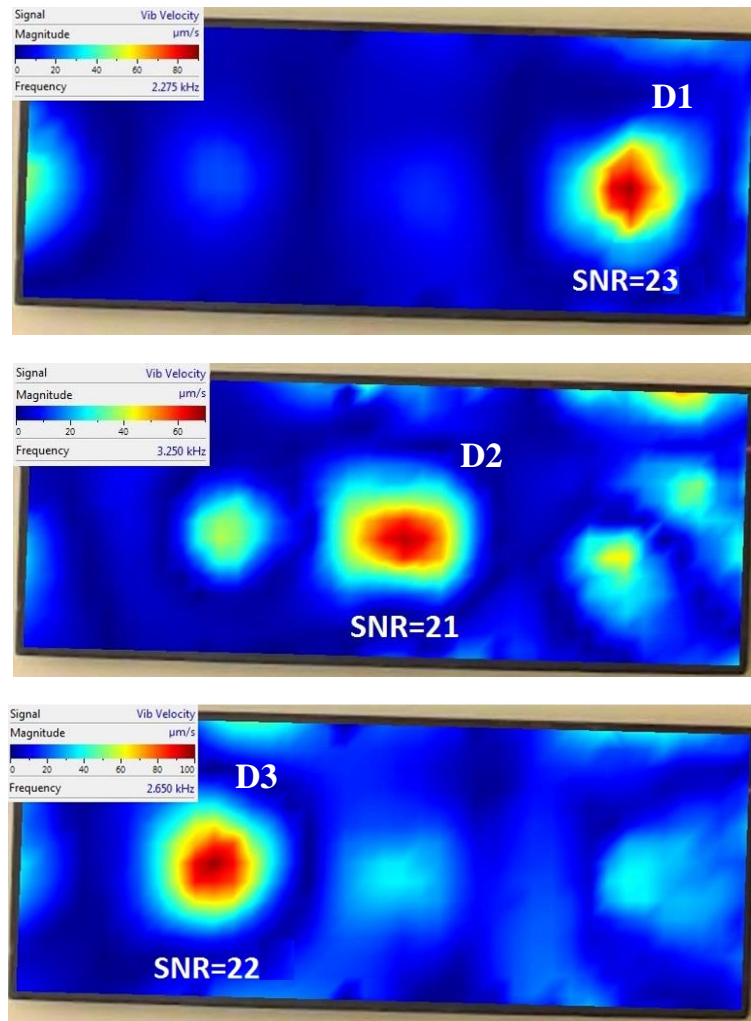
The most important information about defects is supplied by analyzing amplitude-frequency characteristics of samples under test. For each of three defects in the test sample from figure 1, we found resonance frequencies at which local vibrations are maximal (see figure 4). At the frequency of 2.275 kHz, the D1 area was characterized by mean vibration velocity of $62 \mu\text{m/s}$ and produced $\text{SNR}=23$ in regard to mean 'non-defect' vibration of $4.05 \mu\text{m/s}$ (see the formula for SNR above). In the D2 area, the intensity of resonance vibrations exceeded those in a non-defect area by 14 times reaching the value of $51 \mu\text{m/s}$ at the frequency of 3.25 kHz: the corresponding SNR value was 21. Respectively, in the D3 area, the mean vibration amplitude was $73 \mu\text{m/s}$ at the frequency of 2,65 kHz (mean 'non-defect' value $6,5 \mu\text{m/s}$) with the maximum $\text{SNR}=22$.

Fig. 4: Local resonance vibrations: D1 – 2.28 kHz (top), D2 – 3.25 kHz (middle), D3 – 2.65 kHz (bottom)

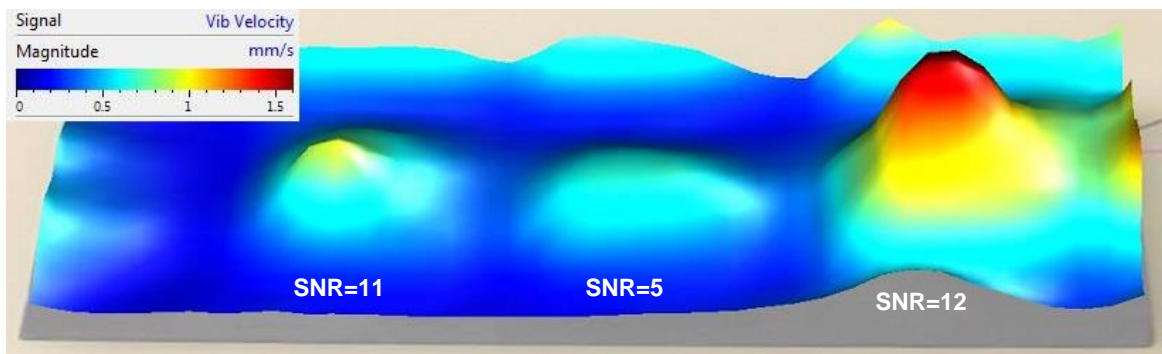
Since the resonance frequencies for all defect areas were close, the technique of laser vibrometry allowed obtaining clear defect patterns in the image of total vibrations even if the corresponding SNR values were 2-4 times lower than in the case of resonance stimulation (figure 5, wide frequency range).

Fig. 5: Total vibration pattern obtained under low-power ultrasonic stimulation by applying SLDV technique (wide frequency range)

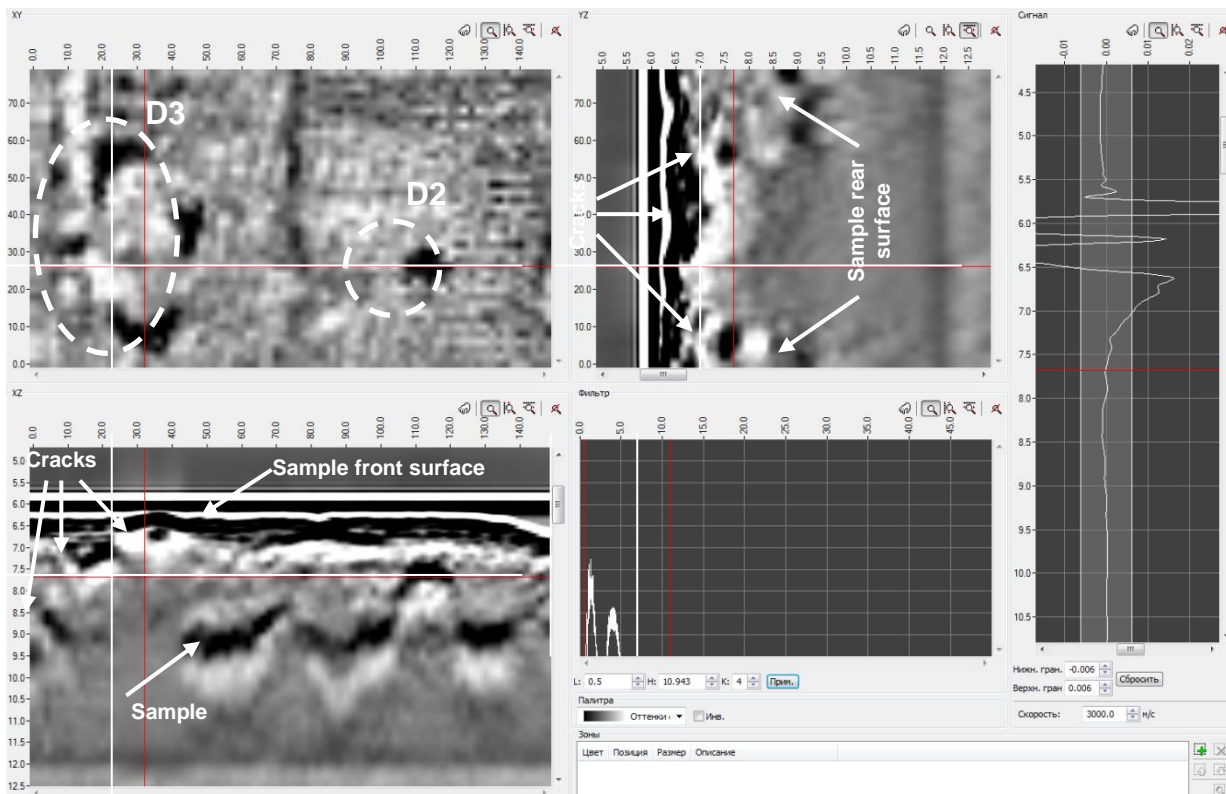
Fig. 6: Example of laser ultrasonic test results (processing program interface)

In figure 6, the sample front sample is represented by a white-colour line because here an ultrasonic pulse penetrates the composite from the medium of lower density; respectively, the rear surface appears as a wide dark line. It is clearly seen that the material is essentially inhomogeneous. It is also characteristic, that, in the defect D2 area, the bottom reflection of the ultrasonic waves occurs at the half sample thickness (see the XZ-plane). The area of impact damage (D3) contains plentiful cracks while the rear-surface signals are absent. In fact, acoustic signals cannot penetrate through the damaged area.

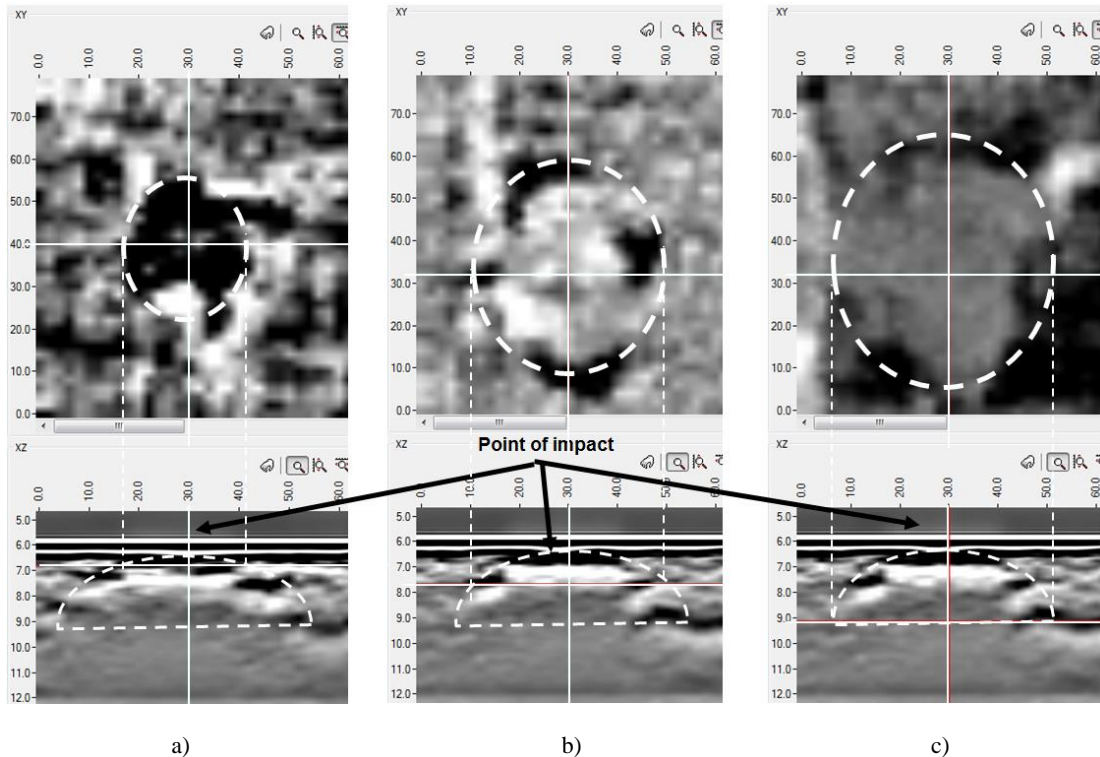
Figure 7 shows some sets of slices in the area of the defect D3. The XZ-planes correspond to different material depths: approximately 0.5, 1.4 and 2.9 mm. By evaluating these results, one can see that the zone of internal structure damage has the form of an inverted cup with the cup bottom placed on the area of front surface impact. The cracks shown in the XY slices look like concentric circles of which radius increase with depth.

Fig. 7: XZ (top row) and XY (bottom row) slices: a - depth 0.5 mm, b - 1.4 mm, c – 2.9 mm
