Application of thermal imaging system for prediction of fatigue crack initiation in Ti-6Al-4V fabricated by EBM

by P. Koruba*, M. Karoluk*, G. Ziólkowski*, E. Chlebus*

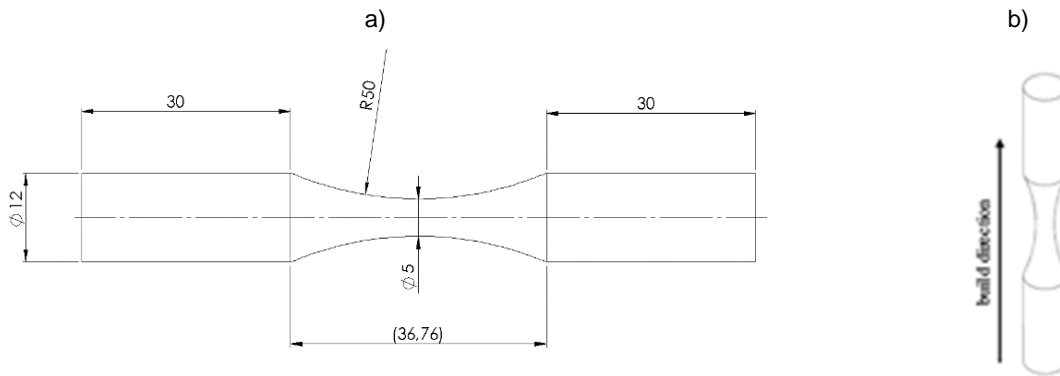
Fig. 1: Fatigue test sample: geometry according to ASTM E466 (a), build direction (b)

For this study, hour-glass shaped specimens according to [12] were fabricated by EBM process using ARCAM A1 machine (Fig. 2 a). All of the samples were built in vertical orientations (Fig. 2 b). For processing Ti-6Al-4V alloy in EBM, ARCAM standard condition was used. After manufacture the specimens were subjected to Hot Isostatic Pressing and then machined to meet ASTM standard.

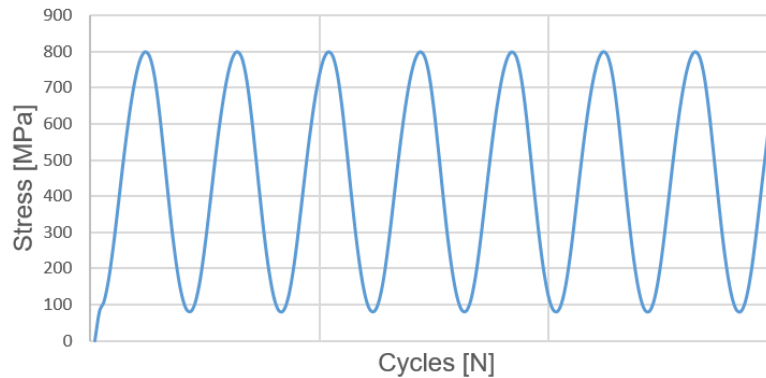
Fig. 2. Exemplary cyclic loading for σ_{max} – 800 MPa

where σ_{max} – maximum stress level and σ_{min} – minimum stress level experienced during the cycle, was established at value 0,1. Tests were performed at 3 stress levels, where σ_{max} was 700 MPa, 800 MPa and 900 MPa. For each stress level the number of specimens used in the tests was 3. It is worth underlying that according to ARCAM standard [13] the yield strength of Ti6Al4V alloy obtained in EBM process is about 950 MPa.

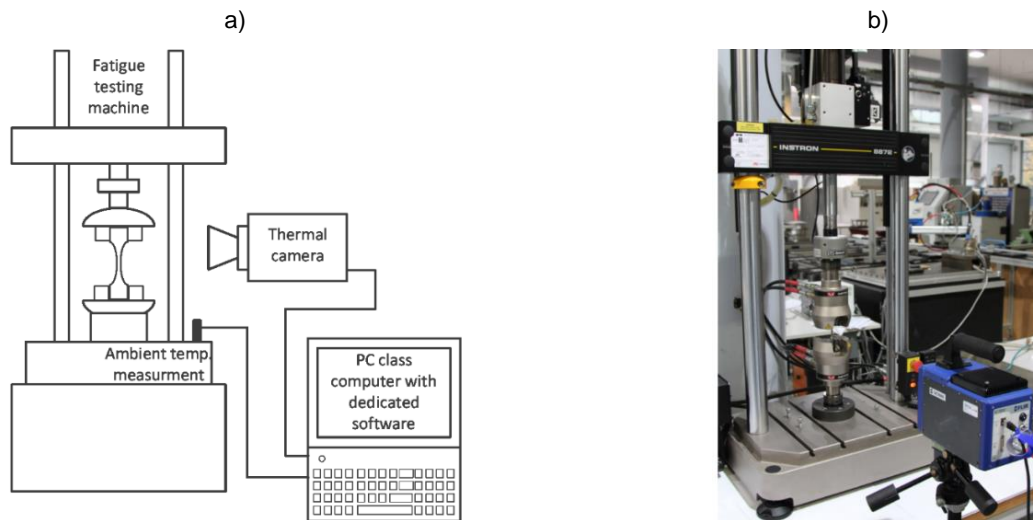
Fig. 3: Experimental site for temperature measurement during fatigue testing: schematics (a), photograph (b)

The thermal imaging system for detection of crack initiation during fatigue testing consisted of thermal camera (FLIR SC7500), acquisition software ResearchIR and microprocessor based ambient temperature measurement system (Fig. 1). The additional temperature sensor DS18B20 was used for detection of ambient temperature changes since fatigue test can be time-consuming. The optics of the camera used for the temperature evaluation was 50 mm standard lens and the measured temperature range was set to 5 °C to 70 °C in camera control. The sampling rate was set to 1 image per second because of the test duration.

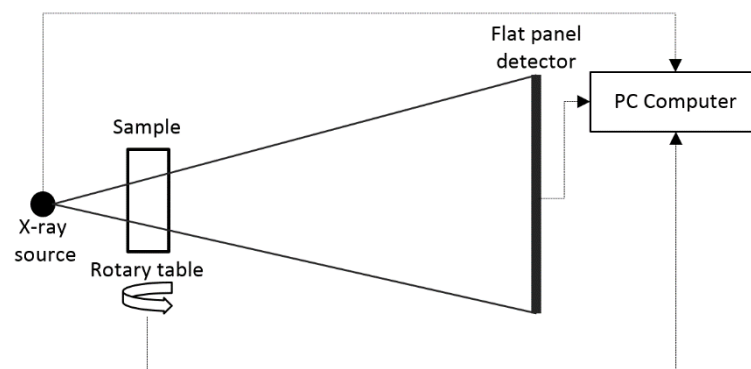
Fig. 4. Schematic illustration of cone beam CT system

In order to evaluate the developed thermal image system for fatigue testing diagnosis and detection of crack initiation a Computer Tomography was utilized. The sample was placed on a rotating table, between x-ray source and flat panel detector, with the axis precisely adjusted to the center of the fan beam (Fig 4). To obtain a high resolution measurement, the sample was placed near the radiation source and only the area covering its central part was reconstructed. During the measurement, sample was illuminated with a radiation beam and single projections for each angular position of the sample, showing the degree of radiation absorption, were recorded.

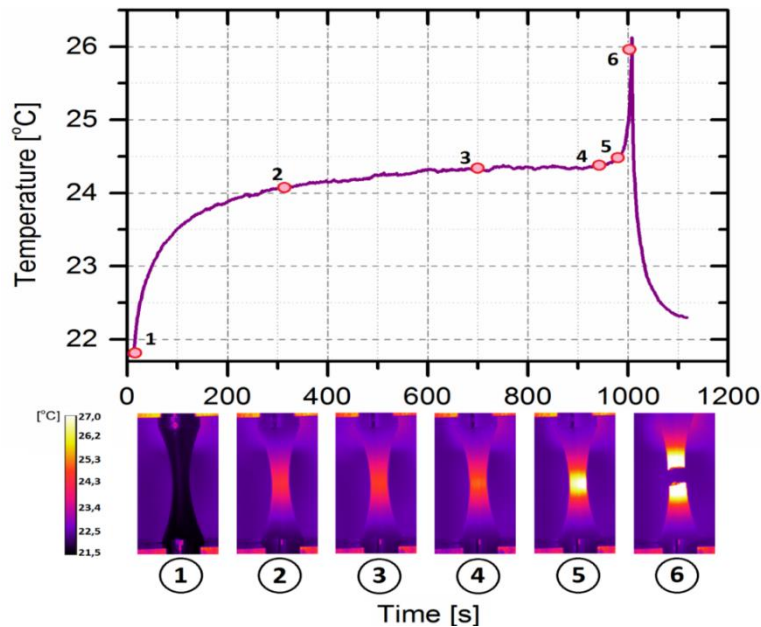
Fig. 5: Temperature of the measuring part of the fatigue sample during the testing with characteristic time steps highlighted: beginning of the test (1), heating-up (2), quasi-steady state (3), subsurface crack initialization (4), subsurface crack propagation (5), fracture of the sample (6)

Although the temperature measurements were conducted for different stress levels, only a representative plot was depicted on figure 5. The sample temperature changes during fatigue testing were shown for 900MPa stress level. Furthermore the images acquired with thermal camera for particular time moments were depicted. Therefore the temperature chart can be divided into several different parts based on the specimen state. At the beginning one can observe fast heating up of the sample and then there is a quasi-steady state with a slight increase in temperature. The most vital part of the plot in case of crack initialisation detection is from point 4 to 6, where the fracture occurs. In order to prevent the specimen from cracking but successfully acquire information about its initialization, the test should be stopped between points (4) and (5). This part of the plot is characterized by the change of the second derivative sign as the temperature plot becomes a convex function and its first derivative is rising.

For more complex analysis the resultative number of cycles (N) and the temperature increase (ΔT) measured between points 4 and 6 on the temperature plot for each of the considered fatigue sample were gathered in table 3. It is worth noticing that N is not a good threshold parameter to stop the fatigue testing. On the other hand, the temperature increase ΔT is not correlated with the stress level or duration of the fatigue test. It might be related with the energy accumulated inside the defect, so indirectly with the size of subsurface crack.

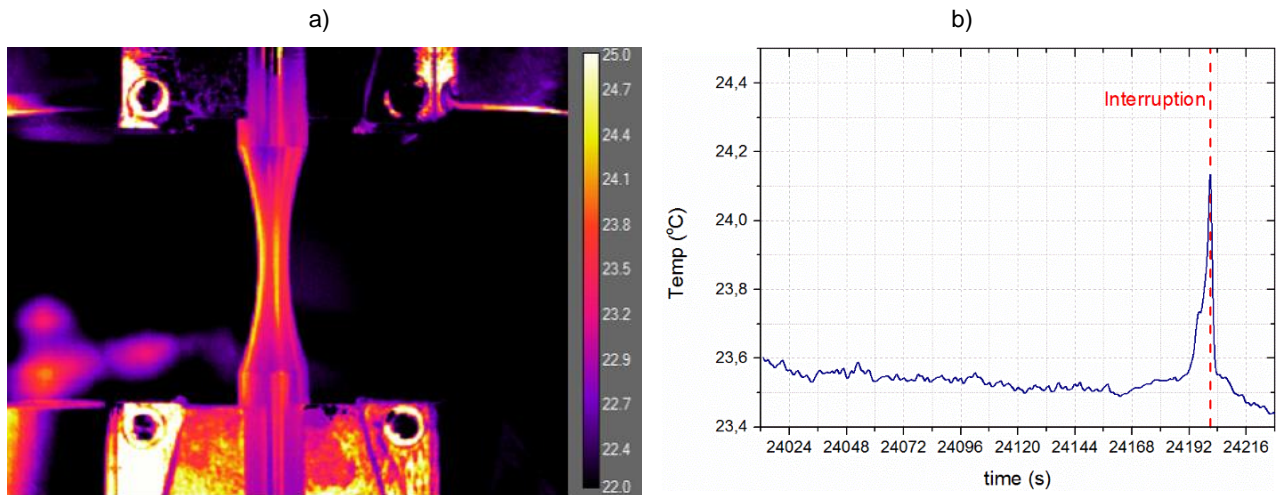
Fig. 6. Data obtained during temperature of fatigue sample: thermal image recorded during test interruption (a), temperature chart for the time period around the interruption (b)

Based on a data discussed above, an exemplary specimen was chosen for fatigue test on 800MPa stress level. The aim of this experiment was to detect the moment, when the crack initialization starts and to interrupt the fatigue test using developed thermal imaging system. In the case of considered sample, the fatigue test was interrupted after 1210047 cycles that was 24201 second from the beginning of the test (Fig. 6). The thermogram shown on Fig. 6a was recorded during interruption of the fatigue test and it shows a heated region on the right side of the specimen axis of symmetry. The temperature increase of the sample was approximately 0.6 °C and there was no trace of the cracking on the surface.

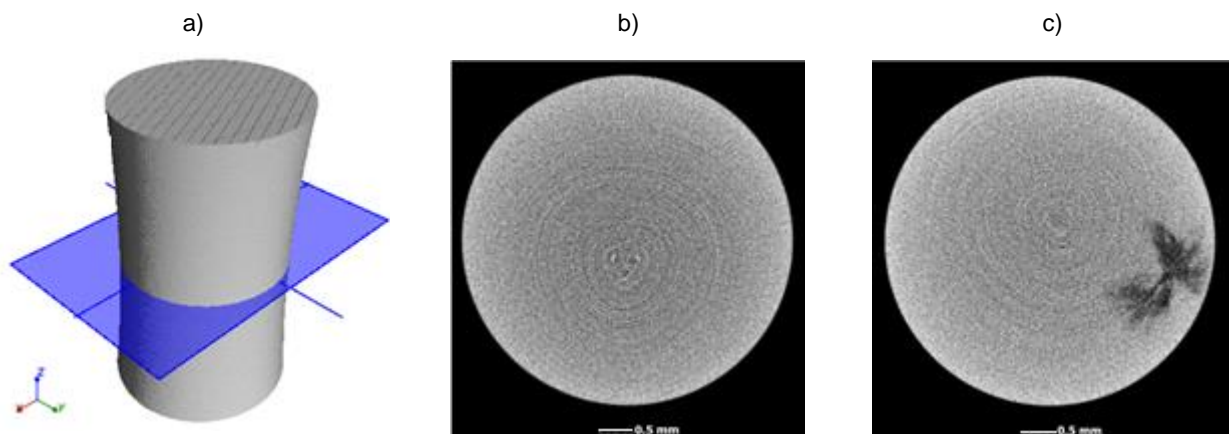
Fig. 7. The result of CT reconstruction: 3D view (a), cross-section before fatigue test (b), cross-section after the crack initiation (c)

In order to detect pores or discontinuities that resulted in heating up of the specimen surfaces, the sample was reconstructed before and after fatigue test. Figure 7a shows the result of the sample reconstruction together with the marked plane to which the corresponding cross-sections before and after crack initiation were compared. CT analysis did not reveal the occurrence any pores or discontinuities for the sample before fatigue test, as shown on the basis of a single 2D projection (Fig. 7b), as well as a transparent 3D view for the entire volume of the sample (Fig. 8a). However, subsurface cracks were observed (Figure 7c) for the sample after fatigue test interruption.

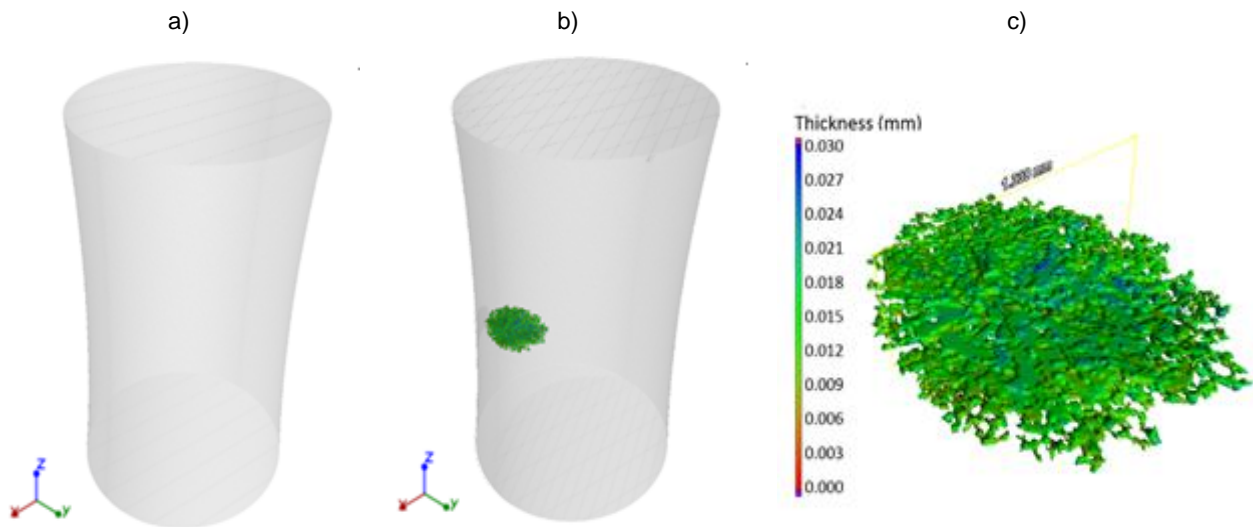
Fig. 8. 3D transparent visualisation: sample scanned before fatigue test (a), sample scanned after the crack initiation (b), crack (fracture) characteristics – dimension and thickness (c)

Additionally, CT analysis also enabled 3D visualization of fracture geometry that was registered at the time of initialization during cycling test, as shown in figures 8b and 8c.

The measured fracture diameter was at the level 1.338 mm (volume of 0.033 mm³), while the thickness did not exceed 30 μ m. Conducted CT examination indicate the occurrence and development of the fracture (crack) when the temperature of the sample, recorded with the use of a thermal imaging camera, increases.

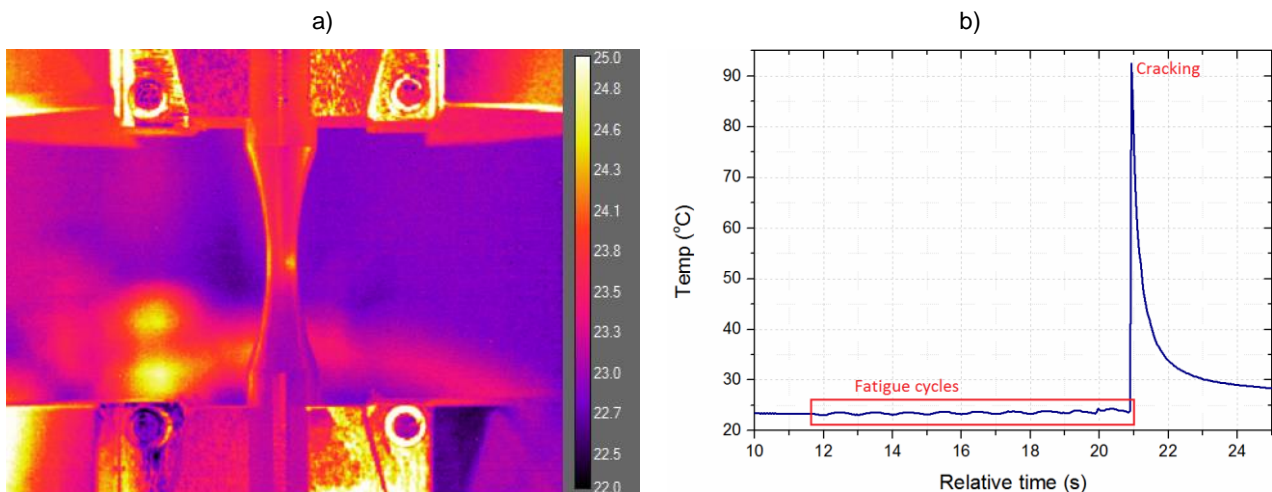
Fig. 9. Data recorded during the cracking of selected fatigue sample: thermogram (a), maximal temperature plot inside measurement part of the sample (b)

After performing several short fatigue tests with a number of cycles, the cracking of the sample was recorded by thermal camera. It is remarkable that in this case the maximal temperature during the fracture increased about 68 °C. The reason of this might be controlled growth of the defect that could accumulate more energy. Before the dramatic increase of maximal temperature inside concerned ROI one can observe sinusoidal change of temperature because of tension-tension cyclic load. This change is noticeable in this case due to increase of frame rate to 25 Hz and the fact, that the loading frequency was reduced to 1 Hz.
