## The continuous thermal imaging of the flood embankment to identify location of the leaks

by B. Bukowska-Belniak\*, A. Borecka\*, A. Leśniak\*

### Abstract

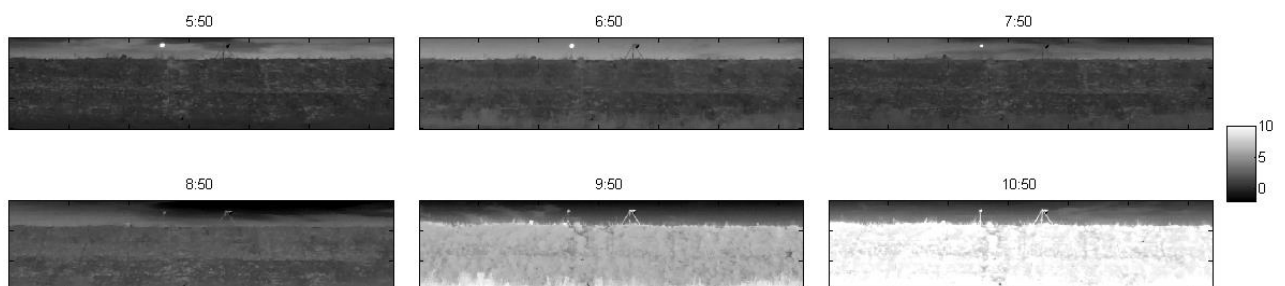
Fig. 1: Thermal images taken in daybreak and morning at 5:50, 6:50, 7:50, 8:50, 9:50 and 10:50 [°C].

The thermographical measurements were carried out during several experiments that were conducted in different seasons and lasts for several days. In November 2016 experiment, during the occurrence of a leak in the NW part of the embankment the stationary thermal image recording was performed with a 5-minute step. Figure 1 presents six images taken by FLIR T620 microbolometer camera. There are no visible places of leaks on the surface of the embankment, despite their occurrence in this area.

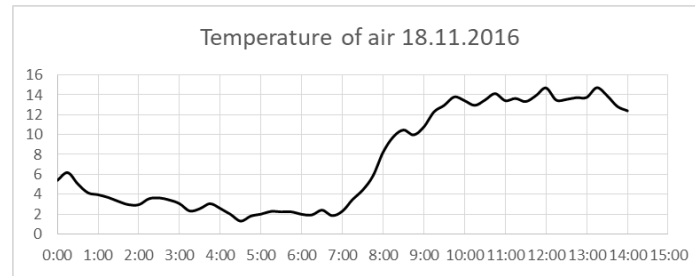
**Fig. 2:** Temperature of air measured by weather station in °C.

As it was shown in figure 2 there was a rapid rise (12°C) in air temperature between 7:00 and 10:00 in that day. The sun rose at 7:00. After 8:00 the temperature of the embankment began to increase.

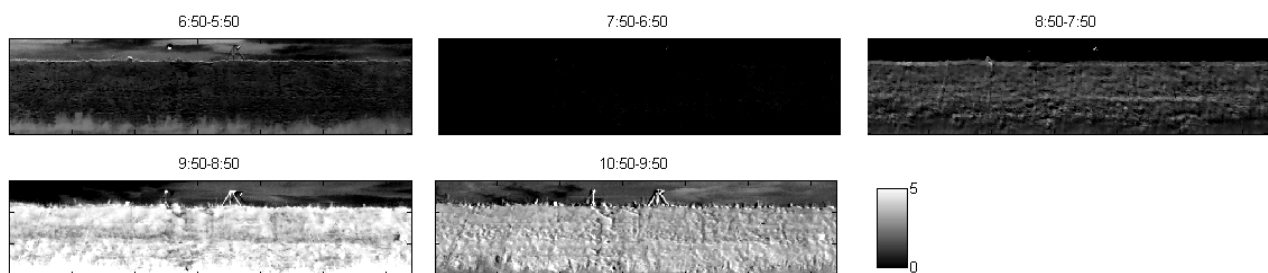
**Fig. 3:** Differences in temperature in each hour of measurement – subtraction images [°C].

There is expected that when air temperature raises in damp areas of the embankment the temperature increases more slowly than in adjacent, dry areas. After performing the subtraction of the consecutive thermal images, the leak regions became visible as can be seen in Figure 3. A strip shape dark area, 1.6 m above embankment base is visible, where more permeable layer of sands exists (fig.3 9:50-8:50).
